**Flood Control Project Maintenance
Levee Inspections**

Fall 2015 Levee Maintenance Deficiency Summary Report

City of Sacramento

**Flood Control Project Maintenance
Levee Inspections
Unit Cover Sheet
Fall 2015 Levee Inspection Results
City of Sacramento**

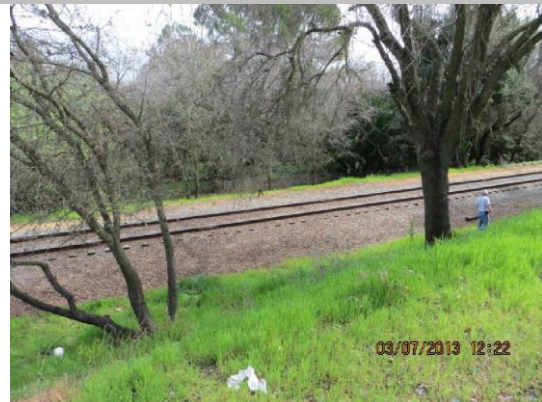
Photo 1 of 2 : UCIP_FA_2015_5955.jpg

LM Start	2.05	Rating **	M	Issue No.	882
LM End	2.05	Issue Type +	En	Location *	CR
Category	Supplemental			GPS Latitude/Longitude	
				Start	End
Item	DWR UCIP Field Study			38.563562 °	38.563562 °
				-121.515867 °	-121.515867 °
DWR ID					
Action/Comments					
Inspector Comments: FS_ID:41294 DS_ID:24922 EP_NO: N/A FS_HLM: 2.055 Repair Type: Non-Urgent Crossing Status: Indicator Found UCIP Comments: Need to contact owner to determine type of crossing and status. Need to find out the alignment of crossing. FIELD_STRUCT_DESC: 2 of 4. Crossing found through railroad/levee visible on landward side. FS Date: 03/06/2013

View of landward side.

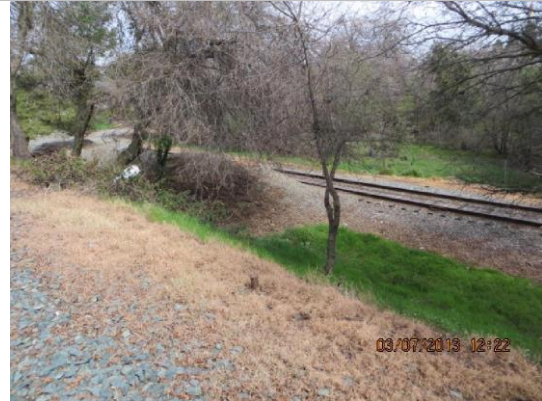
Photo 2 of 2 : UCIP_FA_2015_5958.jpg

LM Start	2.08	Rating **	M	Issue No.	883 (cont)	
LM End	2.08	Issue Type +	En	Location *	CR	
Category	Supplemental			GPS Latitude/Longitude		
				Start	End	
Item	DWR UCIP Field Study			38.563196 °	38.563196 °	
				-121.515833 °	-121.515833 °	
DWR ID						
Action/Comments						
Inspector Comments: FS_ID:41295 DS_ID:24923 EP_NO: N/A FS_HLM: 2.08 Repair Type: Non-Urgent Crossing Status: Indicator Found UCIP Comments: Need to contact owner to determine type of crossing and status. Need to find out the alignment of crossing. FIELD_STRUCT_DESC: 3 of 4. Crossing found through railroad/levee visible on landward side. FS Date: 03/06/2013

View of landward side.

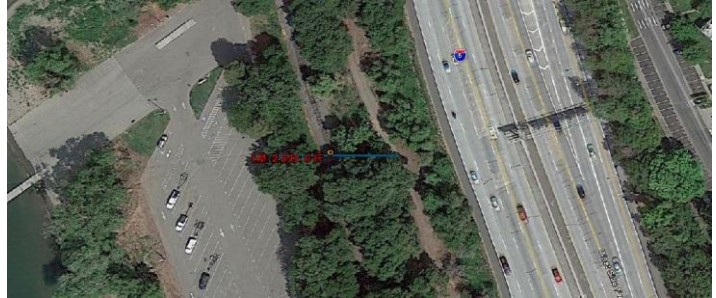
Photo 1 of 1 : UCIP_FA_2015_6129.jpg

LM Start	2.29	Rating **	M	Issue No.	885
LM End	2.29	Issue Type +	En	Location *	WS
Category	Supplemental			GPS Latitude/Longitude	
				Start	End
Item	DWR UCIP Field Study			38.560088 °	38.560088 °
				-121.515150 °	-121.515150 °
DWR ID					
Action/Comments					
Inspector Comments: FS_ID:41431					
DS_ID:24925					
EP_NO: N/A					
FS_HLM: 2.3					
Repair Type: Non-Urgent					
Crossing Status: Indicator Found

Approximate alignment through levee provided by the City of Sacramento GIS.

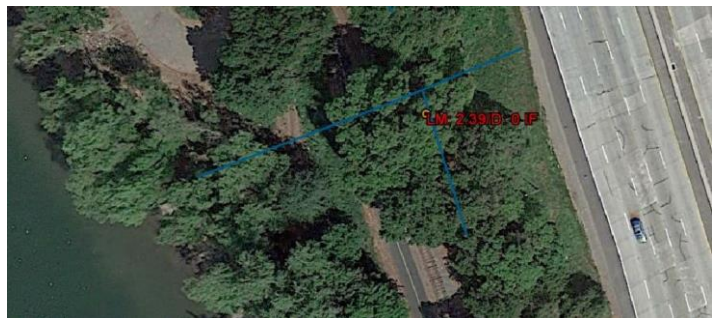
Photo 1 of 1 : UCIP_FA_2015_6130.jpg

LM Start	2.39	Rating **	M	Issue No.	886
LM End	2.39	Issue Type +	En	Location *	WS
Category	Supplemental			GPS Latitude/Longitude	
				Start	End
Item	DWR UCIP Field Study			38.558793 °	38.558793 °
				-121.514460 °	-121.514460 °
DWR ID					
Action/Comments					
Inspector Comments: FS_ID:41433 DS_ID:24926 EP_NO: N/A FS_HLM: 2.39 Repair Type: Non-Urgent Crossing Status: Indicator Found

Approximate alignment for crossing provided by City of Sacramento GIS.

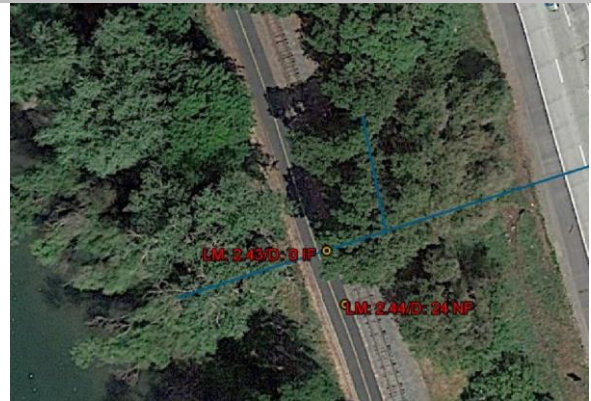
Photo 1 of 1 : UCIP_FA_2015_5961.jpg

LM Start	2.43	Rating **	M	Issue No.	887
LM End	2.43	Issue Type +	En	Location *	WS
Category	Supplemental			GPS Latitude/Longitude	
				Start	End
Item	DWR UCIP Field Study			38.558224 °	38.558224 °
				-121.514365 °	-121.514365 °
DWR ID					
Action/Comments					
Inspector Comments: FS_ID:41296 DS_ID:24927 EP_NO: N/A FS_HLM: 2.43 Repair Type: Non-Urgent Crossing Status: Indicator Found UCIP Comments: Need to coordinate with owner to determine status of crossing--unable to locate in field. FIELD_STRUCT_DESC: 18 inch storm drain at unknown depth. Crossing information was obtained from Sacramento County GIS records. FS Date: 03/06/2013

Approximate alignment of crossing provided by the City of Sacramento.

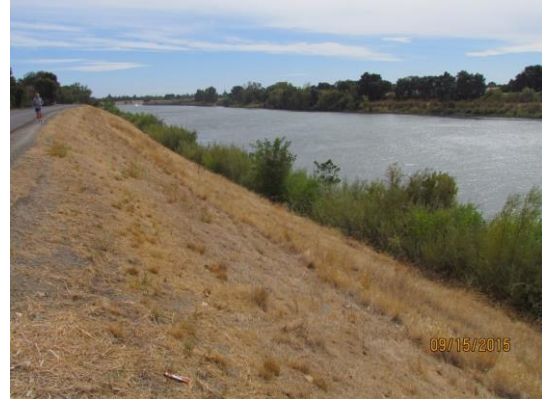
Photo 1 of 2 : FA_2015_NA0005_251_21_20150921_00032.jpg

LM Start	2.46	Rating **	A/W	Issue No.	21
LM End	2.75	Issue Type +	Ob	Location *	WS
Category	Earthen Levee			GPS Latitude/Longitude	
				Start	End
Item	Vegetation			38.557828 °	38.553710 °
				-121.514193 °	-121.512863 °
DWR ID	DWR_NA0005_01_s_2012_21				
Action/Comments					
Environmental Requirements.

View of the revegetation site on the waterward side looking downstream.
Fall 2015.

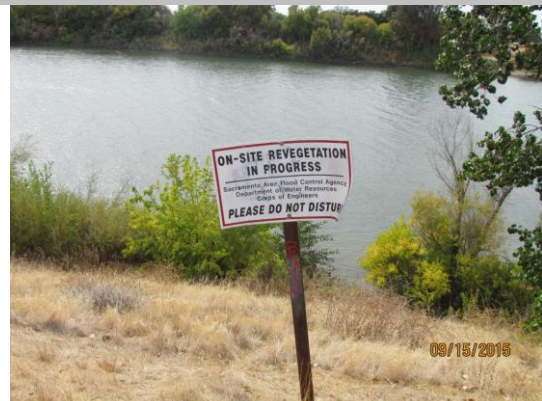
Photo 2 of 2 : FA_2015_NA0005_251_21_20150921_00031.jpg

This area is a revegetation site. Fall 2015.

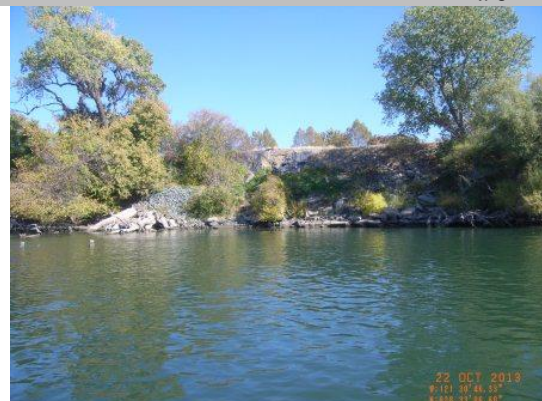
Photo 1 of 1 : USACE2013A_SAC_56-6_L_2.jpg

LM Start	2.85	Rating **	M	Issue No.	2
LM End	2.90	Issue Type +	Ma	Location *	WS
Category	Supplemental			GPS Latitude/Longitude	
				Start	End
Item	2015 USACE Erosion Survey, DRAFT			38.552268 °	38.551578 °
				-121.512590 °	-121.512336 °
DWR ID					
Action/Comments					
Inspector Comments: 1997 - Erosion at pump station, concrete debris and plastic showing. 2000 - Separation scour of bank due to poor transition. 2004 - New large tree pop out; city dumped fill dirt/rock into hole. 2006 - Minor new erosion at top of bank. 2010 - Some new rock placed in tree pop-out. 2011 - A large tree has fallen and flood fighting was performed by the city on the upper levee slope. 2012 - Small rock

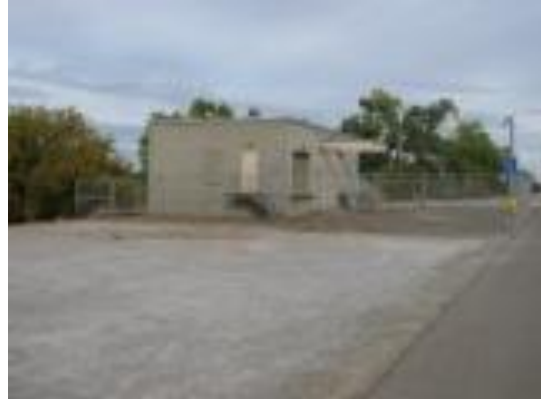
Photo 1 of 1 : FA_2015_NA0005_251_10_20150914_00005.jpg

LM Start	2.89	Rating **	M	Issue No.	10
LM End	2.89	Issue Type +	En	Location *	CR
Category	Earthen Levee			GPS Latitude/Longitude	
				Start	End
Item	Encroachments			38.551810 °	38.551810 °
				-121.511838 °	-121.511838 °
DWR ID	DWR_NA0005_01_s _ 2012_10				
Action/Comments					
Building

City of Sacramento pump station on the waterside of the crown of the levee.

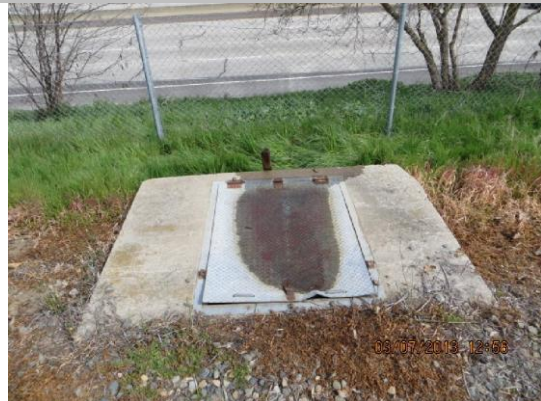
Photo 1 of 3 : UCIP_FA_2015_4159.jpg

LM Start	2.89	Rating **	M	Issue No.	888
LM End	2.89	Issue Type +	En	Location *	CR
Category	Supplemental			GPS Latitude/Longitude	
				Start	End
Item	DWR UCIP Field Study			38.551797 °	38.551797 °
				-121.511859 °	-121.511859 °
DWR ID					
Action/Comments					
Inspector Comments: FS_ID:45133 DS_ID:21578 EP_NO: 2043 FS_HLM: 2.9021 Repair Type: Non-Urgent Crossing Status: Found UCIP Comments: This crossing has been abandoned. According to City of Sacramento Staff the last time this crossing was fired up to see if it was functioning was 3 years ago. Recommend owner coordinating with Central Valley Flood Protection Board (CVFPB) to abandon facility per Title 23. FIELD_STRUCT_DESC: Ranney collector on waterward slope. Ranney collector with 24 inch discharge pipe through levee. (Permit No. 2043, City of Sacramento-1955). FS Date: 03/07/2013

Close up view of vault located on landward levee shoulder.

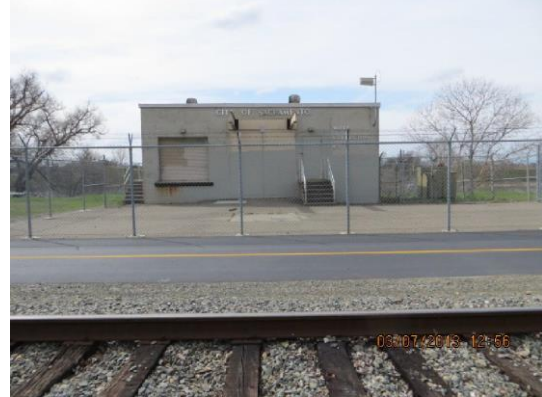
Photo 2 of 3 : UCIP_FA_2015_4160.jpg

Inspector Comments: FS_ID:45133
 DS_ID:21578
 EP_NO: 2043
 FS_HLM: 2.9021
 Repair Type: Non-Urgent
 Crossing Status: Found
 UCIP Comments: This crossing has been abandoned. According to City of Sacramento Staff the last time this crossing was fired up to see if it was functioning was 3 years ago. Recommend owner coordinating with Central Valley Flood Protection Board (CVFPB) to abandon facility per Title 23.
 FIELD_STRUCT_DESC: Ranney collector on waterward slope. Ranney collector with 24 inch discharge pipe through levee. (Permit No. 2043, City of Sacramento-1955).
 FS Date: 03/07/2013

Ranney collector facility operated by the City of Sacramento.

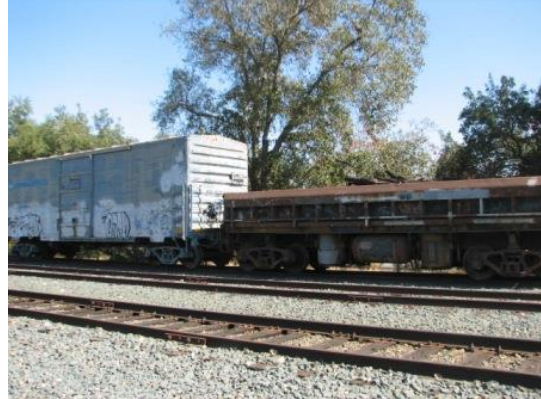
Photo 1 of 1 : FA_2015_NA0005_251_9_20150914_00004.jpg

LM Start	3.29	Rating **	M	Issue No.	9
LM End	3.29	Issue Type +	En	Location *	CR
Category	Earthen Levee			GPS Latitude/Longitude	
				Start	End
Item	Encroachments			38.546302 °	38.546302 °
				-121.510197 °	-121.510197 °
DWR ID	DWR_NA0005_01_f _ 2013_9				
Action/Comments					
Equipment					
Inspector Comments: There are four cars on the levee crown.

Trains cars are stored on the crown of the levee. Fall 2013
